Manhole Inspection Summary

Manhole # S65I__015MH

Location Address: **540 Dundalk Ave.**

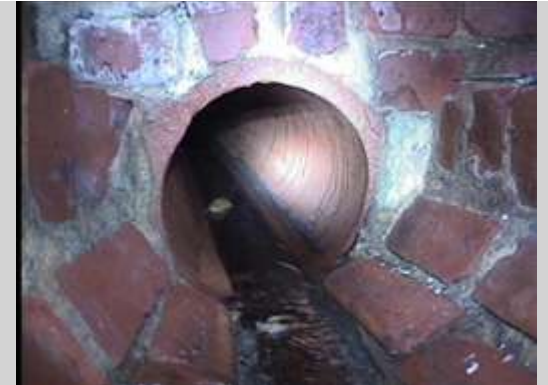
12 O'Clock Outflow

8 in. Circular Gravity Sewer
Pipe Out @ 12 O'Clock

Pipe Height: **8.4** (in.) Rod and Bar (Angled)
Pipe Material: **Clay** ☐ Pipe Lined
Invert Depth: **10.40** (ft.) Flow Characteristics: **Slow**
Deposits: ☒ None ☐ Mud ☐ Sludge ☐ Debris ☐ Grease
Silt Depth: (in.) Deposits Extent:
Infiltration: **None** Pipe Seal Cond: **Sound**

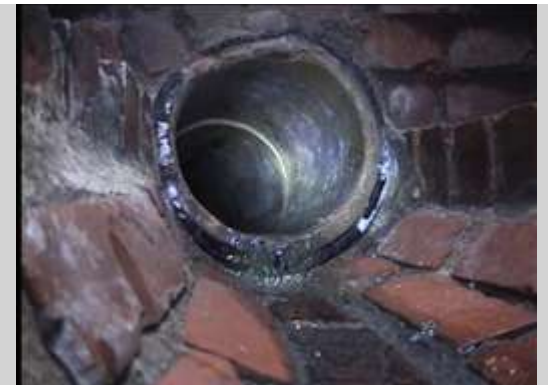
6 O'Clock Inflow

8 in. Circular Gravity Sewer
Pipe In @ 6 O'Clock

Pipe Height: **8.4** (in.) Rod and Bar (Angled)
Pipe Material: **Clay** ☐ Pipe Lined
Invert Depth: **9.60** (ft.) Flow Characteristics: **Slow**
Deposits: ☒ None ☐ Mud ☐ Sludge ☐ Debris ☐ Grease
Silt Depth: (in.) Deposits Extent:
Infiltration: **None** Pipe Seal Cond: **Sound**
